**Flood Control Project Maintenance
Levee Inspections**

Spring 2012 Levee Inspection Results

Reclamation District No. 0307 Lisbon

Waterway			Bank	Unit Miles
Unit No. 01 Sacramento River			Right	6.65
	Spring (March - May)	Summer (June - August)	(September - November) Fall	Winter (December - February)
Unit Maintenance Rating (Fall Only)				
Date of Inspection	3/12/2012 - 3/12/2012			
DWR Inspector	Herman Phillips			
Accompanied By	Pete Dwyer RD 307

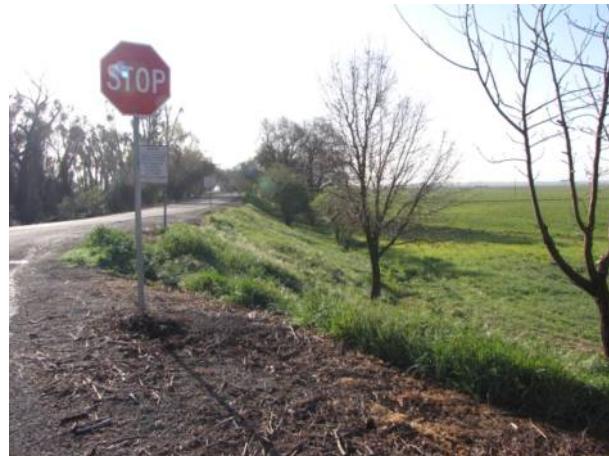
Levee Mile Report Line	4
Start Levee Mile	0.00
End Levee Mile	0.00
Location	Land Side
Category	Earthen Levee
Item	Vegetation
RD 307 Looking downstream from levee mile 0.00 landside slope. Photo taken 3-12-2012.	
phillips_s_20120316_364.jpg

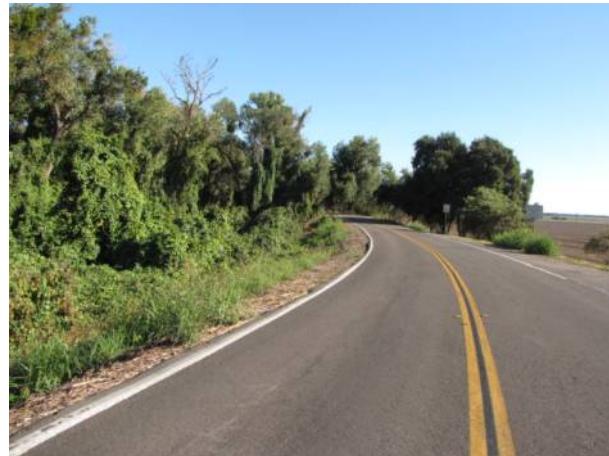
Levee Mile Report Line	5
Start Levee Mile	0.10
End Levee Mile	0.10
Location	Water Side
Category	Earthen Levee
Item	Vegetation
Standing on water side levee mile 0.10 looking downstream of RD 307. Photo taken 10-06-2011.	
phillips_s_20120306_070.jpg

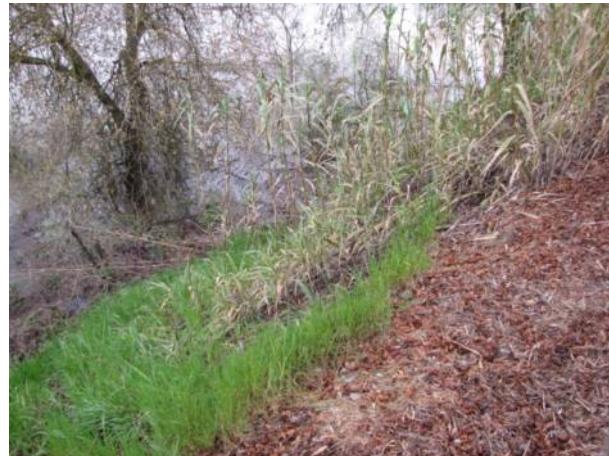
Levee Mile Report Line	17
Start Levee Mile	2.43
End Levee Mile	2.45
Location	Water Side
Category	Earthen Levee
Item	Erosion / Bank Caving
Looking downstream from waterside levee mile 2.43 at erosion on bank, you can't see the erosion very good because of the overgrowth of bamboo. Photo taken 3-18-2011. This site was discovered by the land owner Mr. Borges.	
phillips_s_20120306_068.jpg

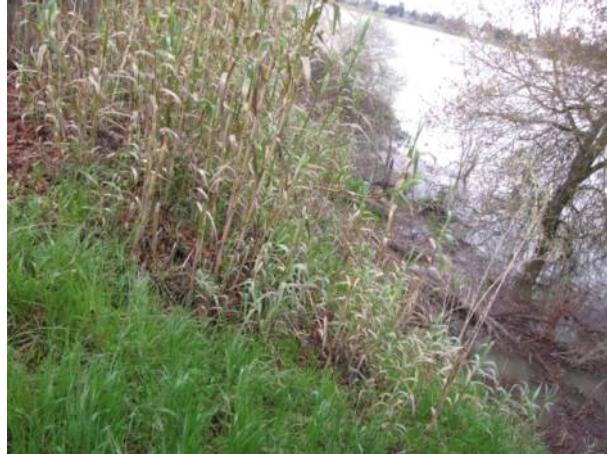
Levee Mile Report Line	17
Start Levee Mile	2.43
End Levee Mile	2.45
Location	Water Side
Category	Earthen Levee
Item	Erosion / Bank Caving
Looking back upstream from levee mile 2.45 end of the erosion, the bamboo has blocked the actual viewing of the eroded site. Photo taken 3-18-2011.	
phillips_s_20120306_069.jpg

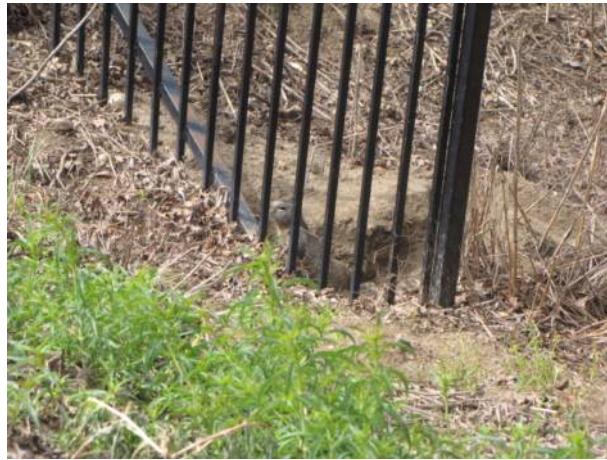
Levee Mile Report Line	24
Start Levee Mile	3.54
End Levee Mile	3.56
Location	Land Side
Category	Earthen Levee
Item	Animal Control
Photo shows a live rodent near fence outside of his burrow.	
phillips_s_20120306_067.jpg

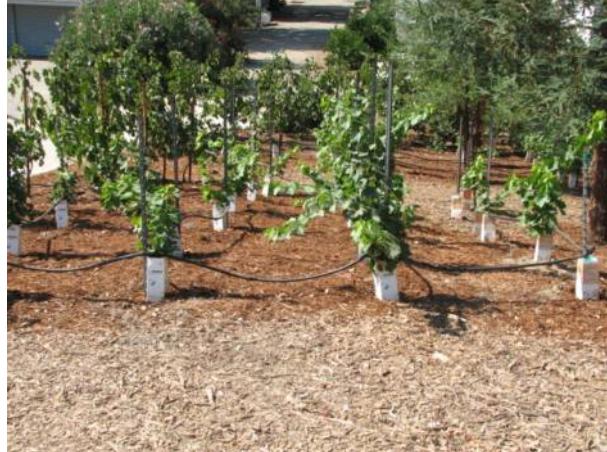
Levee Mile Report Line	39
Start Levee Mile	4.43
End Levee Mile	4.44
Location	Land Side
Category	Earthen Levee
Item	Encroachments
Unauthorized grape vines with driplines placed within levee shoulder and slope, levee miles 4.43 to 4.44 38.443798 121.50332 and 38.44365086 - 121.50322 land side. There is no permit for this encroachment.	
phillips_s_20120306_078.jpg

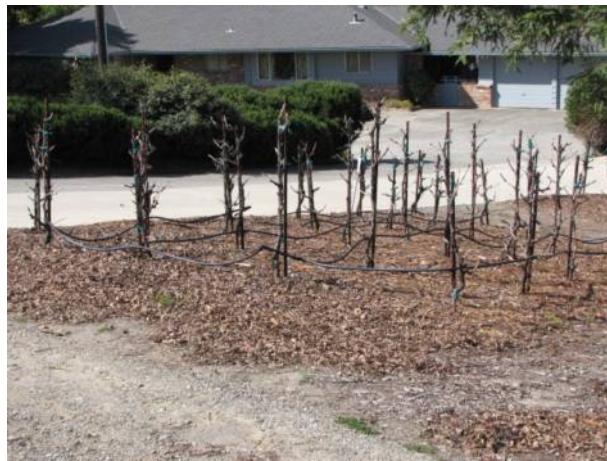
Levee Mile Report Line	39
Start Levee Mile	4.43
End Levee Mile	4.44
Location	Land Side
Category	Earthen Levee
Item	Encroachments
Unauthorized grape vines still on landward slope. Photo taken 3-12-2012.	
phillips_s_20120319_367.jpg

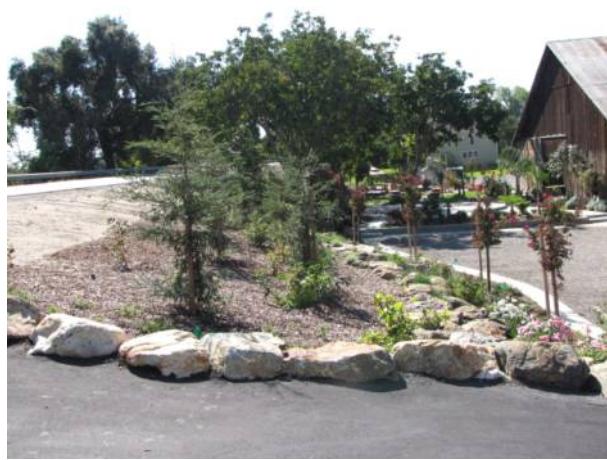
Levee Mile Report Line	40
Start Levee Mile	4.64
End Levee Mile	4.68
Location	Land Side
Category	Earthen Levee
Item	Vegetation
At this location levee mile 4.64 thru 4.68 shows some of the unauthorized trees and landscaping as well as sprinkler system on the slope and toe of the levee section. This photo was taken 3-2012.	
phillips_s_20120316_366.jpg

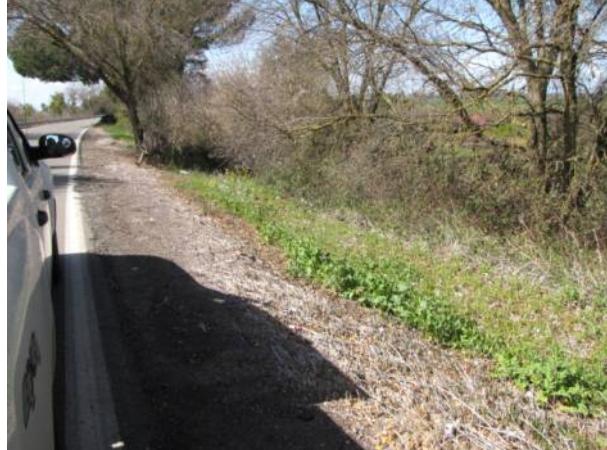
Levee Mile Report Line	44
Start Levee Mile	5.21
End Levee Mile	5.23
Location	Land Side
Category	Earthen Levee
Item	Vegetation
Levee mile 5.21-5.23 wild berries on landward slope and toe of levee section. Photo taken 3-12-2012.	
phillips_s_20120319_368.jpg

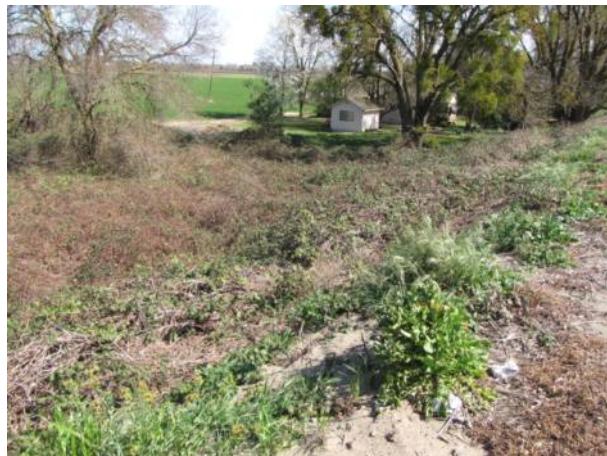
Levee Mile Report Line	48
Start Levee Mile	5.71
End Levee Mile	5.74
Location	Land Side
Category	Earthen Levee
Item	Vegetation
Looking upstream from levee mile 5.74 land side to levee mile 5.71. Wild berries has covered the landward slope and toe. Photo taken 3-12-2012.	
phillips_s_20120316_365.jpg

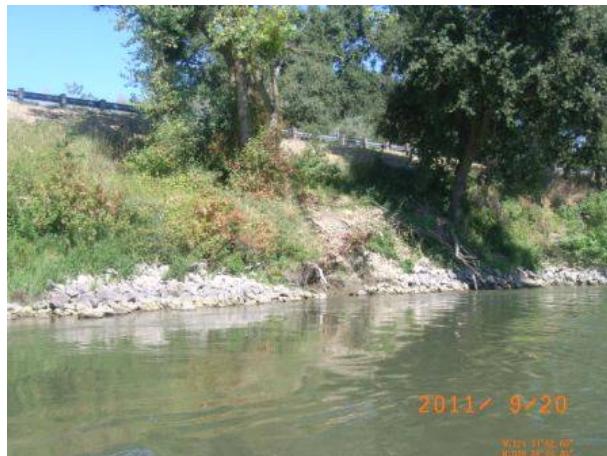
-121.522462 °	-121.523173 °		
								DWR ID: DWR_RD0307_01_s_2012_52			
50	6.03	6.54	Earthen Levee	Vegetation	LS En	M	V6 : Landscaping	38.436153 °	38.431365 °	56	
								-121.527540 °	-121.533490 °		
								DWR ID: DWR_RD0307_01_s_2012_56			
51	6.16	6.42	Supplemental USACE Erosion Survey	WS Ma	M		Inspector Comments: 2008 - Large rotational failure in bank and well into the levee slope. Could be a significant problem in the next high flow event. 2009 - Minimal new erosion, site extended upstream. 2010 - Minor new erosion. 2011: Tree popout has left a large hole. Large slump area. Rock on the bank is failing in some locations. [2011 Site ID: SAC_43-2_R]	38.434560 °	38.432287 °	6	
								-121.531159 °	-121.532978 °	Y	
								DWR ID: DWR_RD0307_01_s_2012_6			
52	6.38	6.49	Supplemental USACE Erosion Survey	WS Ma	M		Inspector Comments: 2011: Erosion pockets likely from tree popouts. This site has been in the inventory before and been fixed with emergency bank rock but continues to fail. [2011 Site ID: SAC_43-1_R]	38.431726 °	38.429957 °	7

Levee Mile Report Line	51
Start Levee Mile	6.16
End Levee Mile	6.42
Location	Water Side
Category	Supplemental
Item	USACE Erosion Survey
USACE 2011 Photo #1	
phillips_s_20120306_071.jpg

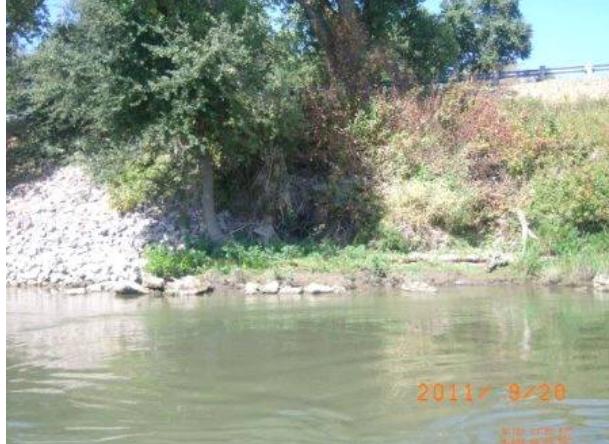
USACE 2011 Photo #2

Levee Mile Report Line	51
Start Levee Mile	6.16
End Levee Mile	6.42
Location	Water Side
Category	Supplemental
Item	USACE Erosion Survey

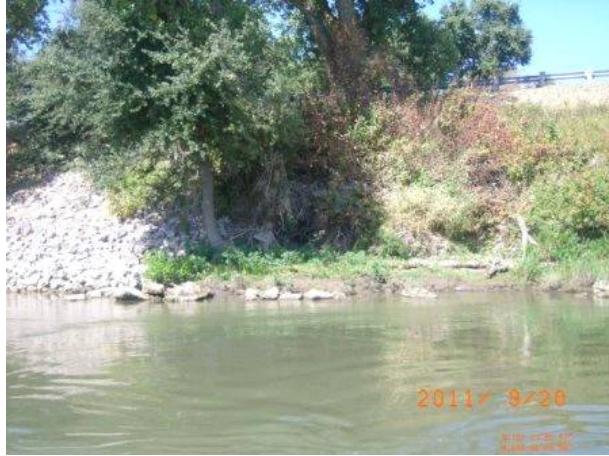
USACE 2011 Photo #3
phillips_s_20120306_073.jpg

Levee Mile Report Line	51
Start Levee Mile	6.16
End Levee Mile	6.42
Location	Water Side
Category	Supplemental
Item	USACE Erosion Survey

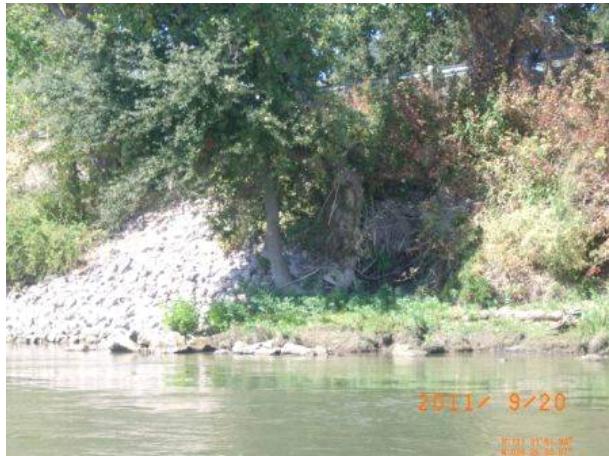
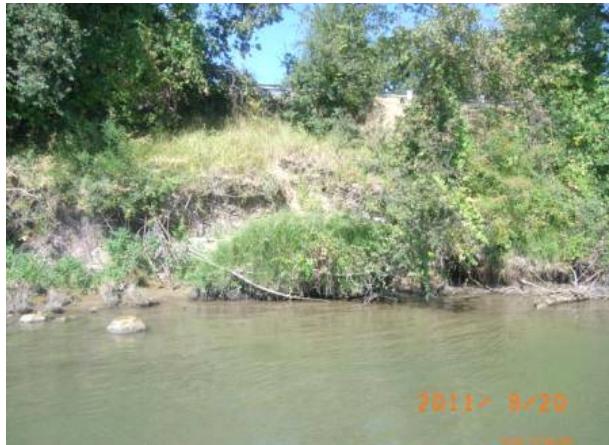
USACE 2011 Photo #4
phillips_s_20120306_074.jpg

Levee Mile Report Line	51
Start Levee Mile	6.16
End Levee Mile	6.42
Location	Water Side
Category	Supplemental
Item	USACE Erosion Survey

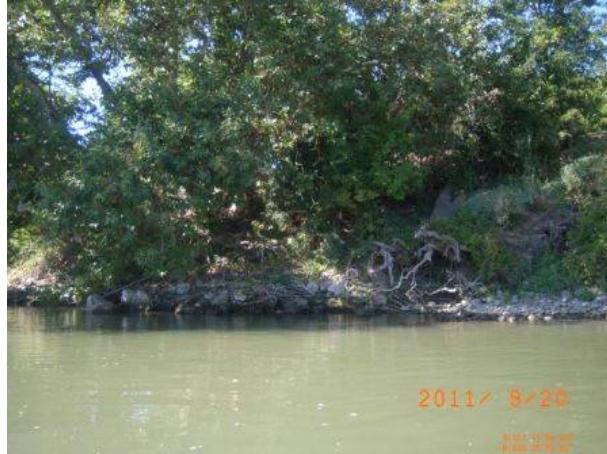
USACE 2011 Photo #1

Levee Mile Report Line	52
Start Levee Mile	6.38
End Levee Mile	6.49
Location	Water Side
Category	Supplemental
Item	USACE Erosion Survey

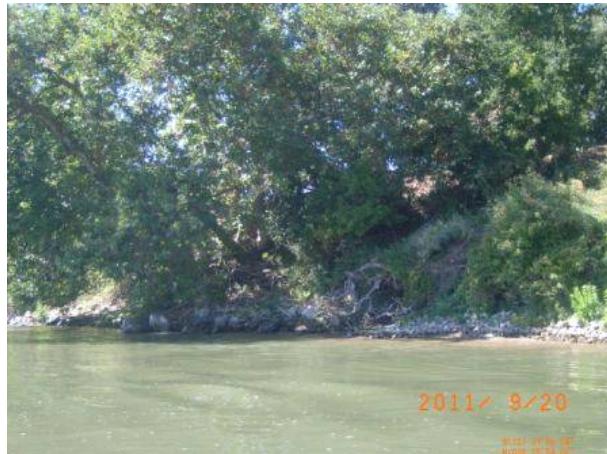
USACE 2011 Photo #2

Levee Mile Report Line	52
Start Levee Mile	6.38
End Levee Mile	6.49
Location	Water Side
Category	Supplemental
Item	USACE Erosion Survey

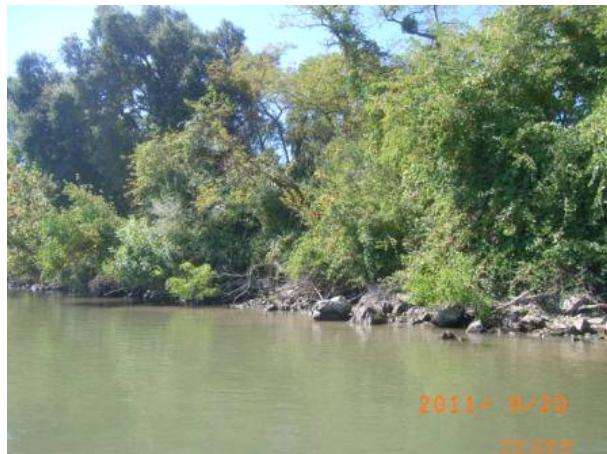
USACE 2011 Photo #3

Levee Mile Report Line	52
Start Levee Mile	6.38
End Levee Mile	6.49
Location	Water Side
Category	Supplemental
Item	USACE Erosion Survey
